RE: IMPORTANT SAFETY NOTICE: IMMEDIATE ACTION REQUIRED

Inspection Procedure for Secondary Sealant of Insulating Glass Units

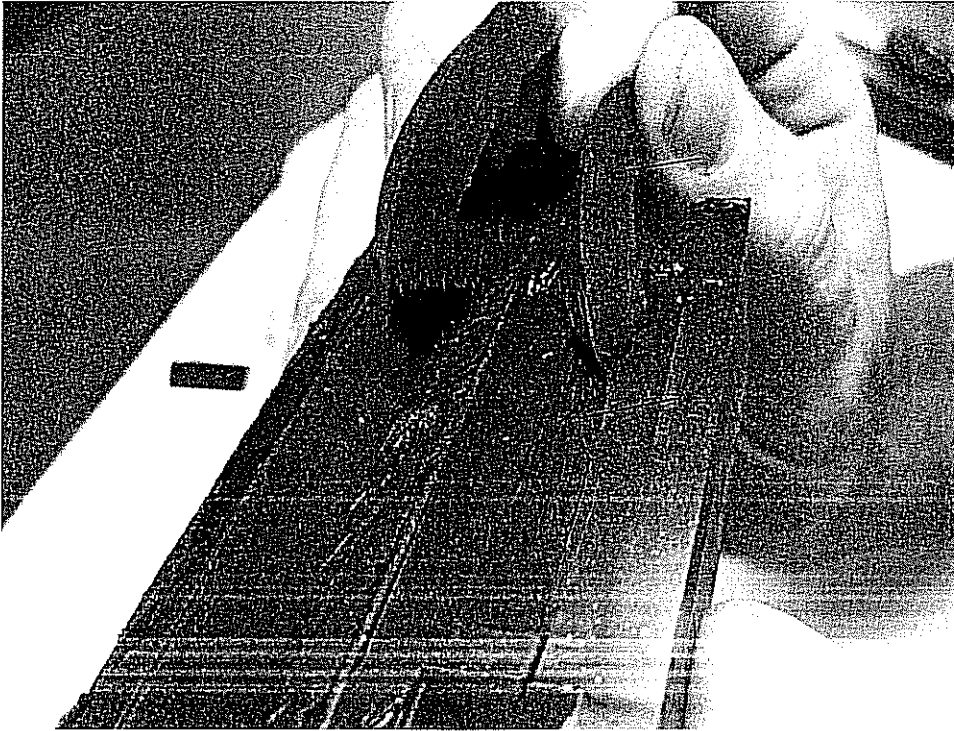
Figure 7 – Edge of IG Unit with Wedge Cut (Left – Acceptable)

4. Inspect the interior of the wedge cut for bubbles.

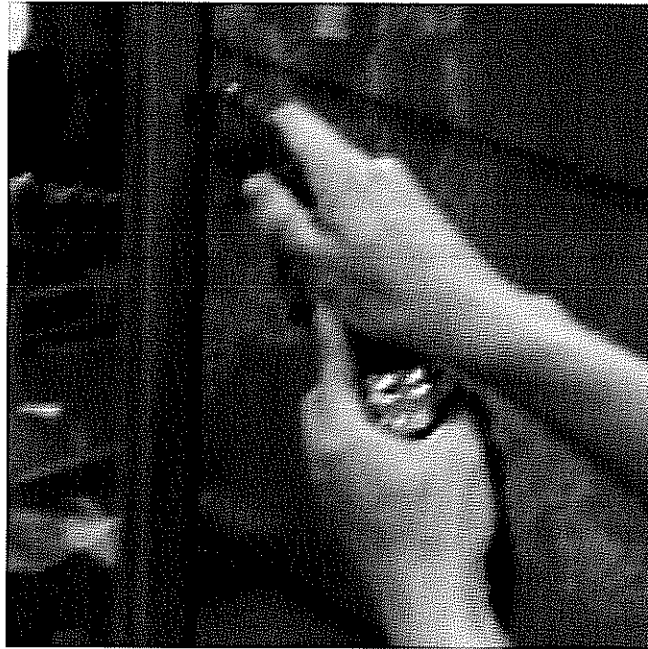
Figure 6 – Wedge Cutting IG Sealant

3. Additional verification: In cases where inspection has demonstrated an observance of bubbles being limited to less than a twelve inch section, or should additional inspection be desired, a triangular slice could be cut from the insulating glass sealant in such a manner as to not damage the PIB. This section should be 4-6" in length at minimum. Insert the knife at an angle and cut both sides of the sealant, removing a triangular shaped section of sealant.

6. Areas which have been wedge cut for inspection and areas with intermittent bubbles can be patched and repaired using Dow Corning® 995 Silicone Structural Sealant. Repair any wedge cut location and any intermittent bubble locations found using Dow Corning® 995 Silicone Structural Sealant.

- a. For wedge cut repair, install the 995 sealant and tool. Cleaning should not be necessary as this is freshly cut sealant.
 - b. For repairing units in which sealant must be fully removed from intermittent bubbled locations, remove all of the secondary sealant and get the glass surface as clean as possible using sharp knives. The glass should not need to be cleaned provided the bubbled surface layer is removed with a sharp knife. Reinstall and tool the 995.

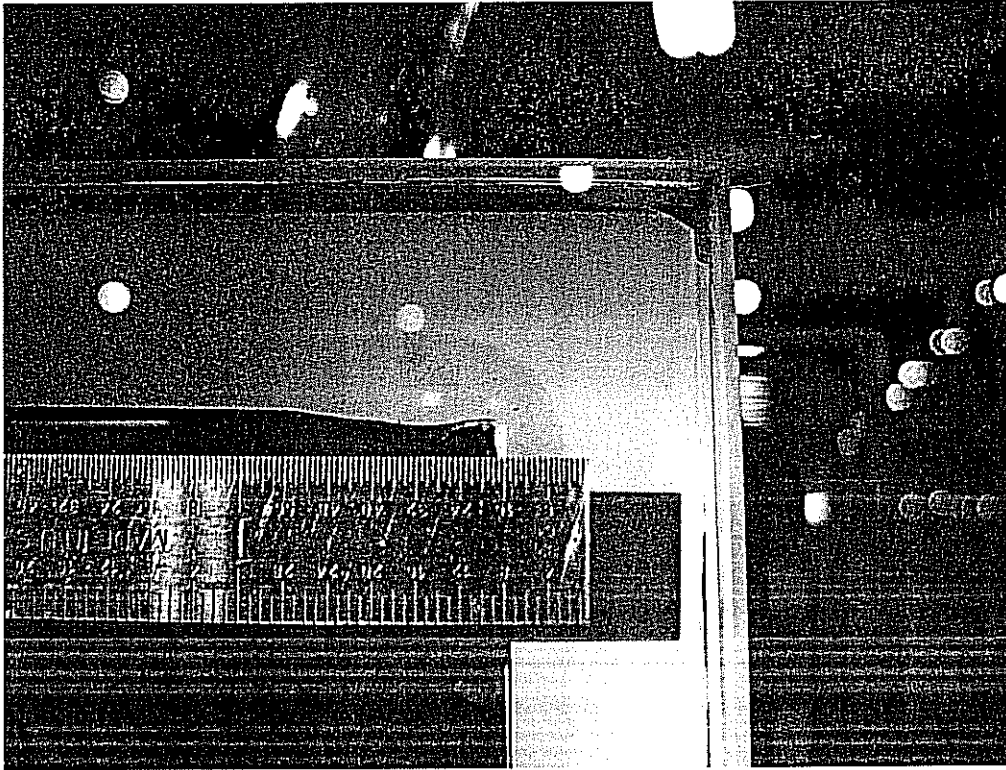
Figure 4 - Acceptable Gray Sealant Line, Bubble Free

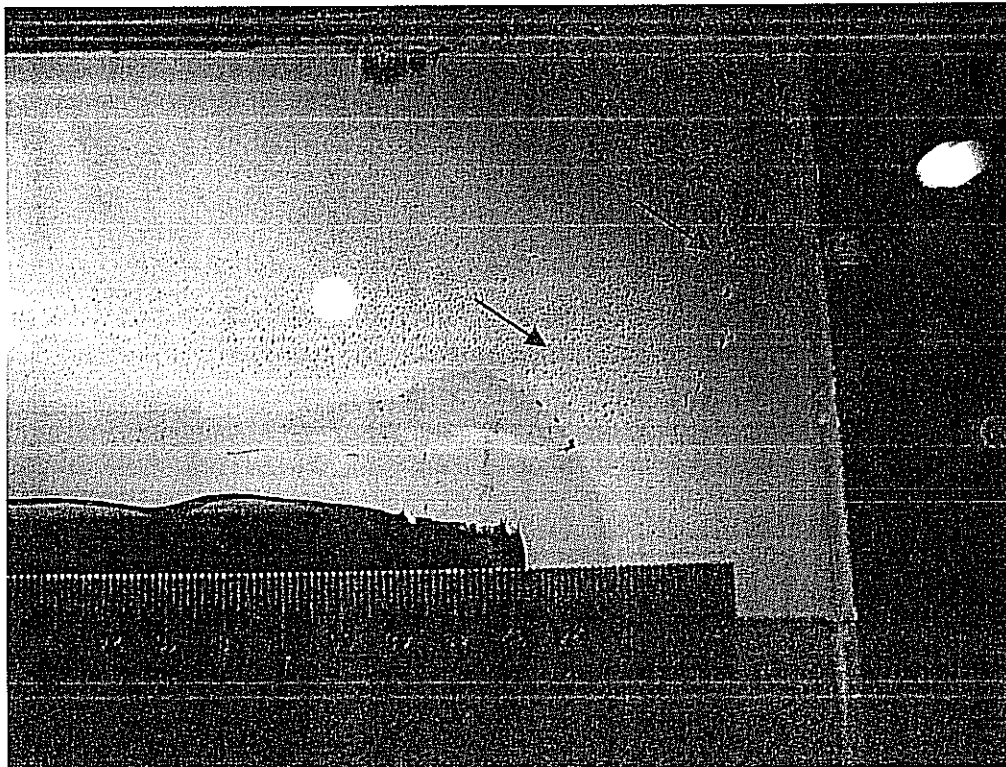
Figure 5 – Example of Micro-Bubbles in Gray Sealant – Not Acceptable

5. In the event that a unit has been deemed questionable, please document and identify the region in question, for example with a color tape, for future review.
