RE: IMPORTANT SAFETY NOTICE: IMMEDIATE ACTION REQUIRED

Inspection Procedure for Secondary Sealant of Insulating Glass Units

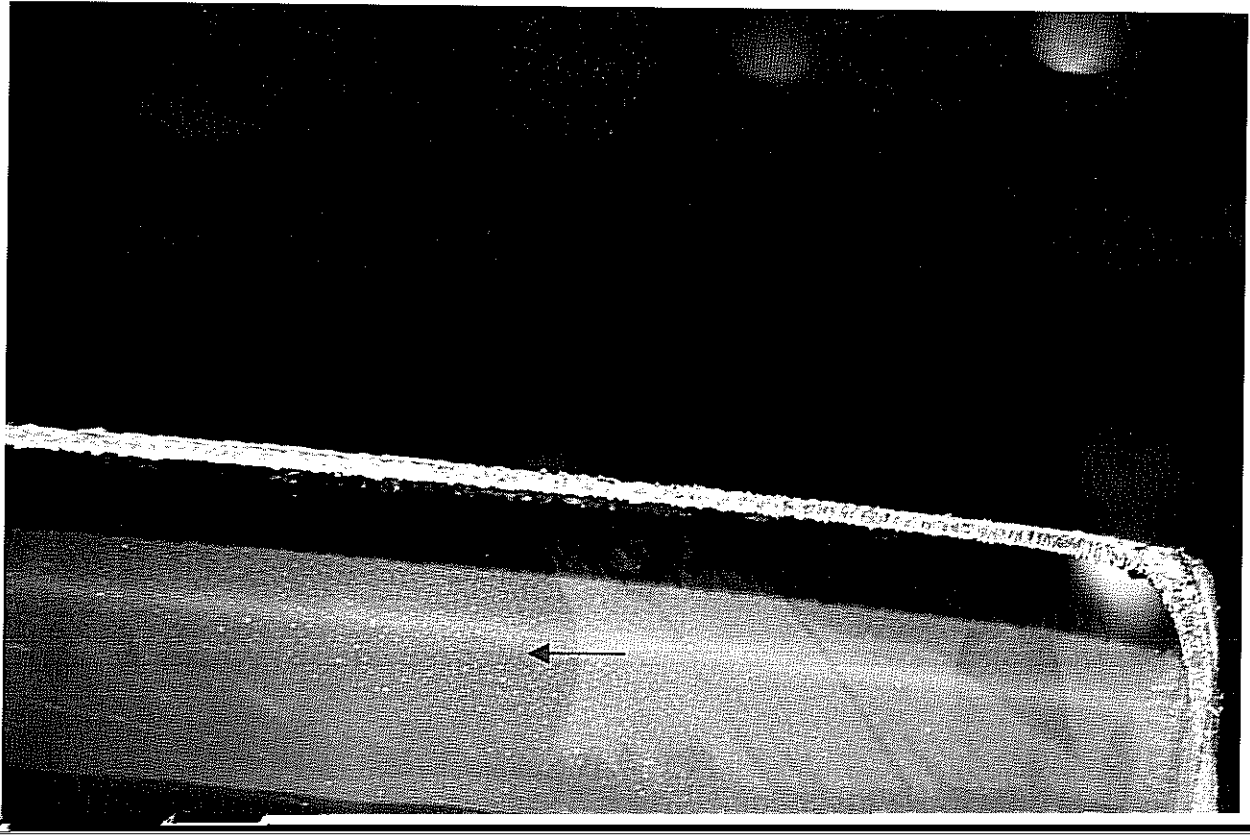
Figure 7 – Edge of IG Unit with Wedge Cut (Left – Acceptable)

6. Areas which have been wedge cut for inspection and areas with intermittent bubbles can be patched and repaired using Dow Corning® 995 Silicone Structural Sealant. Repair any wedge cut location and any intermittent bubble locations found using Dow Corning® 995 Silicone Structural Sealant.

- a. For wedge cut repair, install the 995 sealant and tool. Cleaning should not be necessary as this is freshly cut sealant.
 - b. For repairing units in which sealant must be fully removed from intermittent bubbled locations, remove all of the secondary sealant and get the glass surface as clean as possible using sharp knives. The glass should not need to be cleaned provided the bubbled surface layer is removed with a sharp knife. Reinstall and tool the 995.
